# Mechanical Trauma as a Cause of Late Complications

after AneuRx® Stent Graft Repair  
of Abdominal Aortic Aneurysms

Zvonimir Krajcer, MD  
Kamal Gupta, MD  
Kathy G. Dougherty

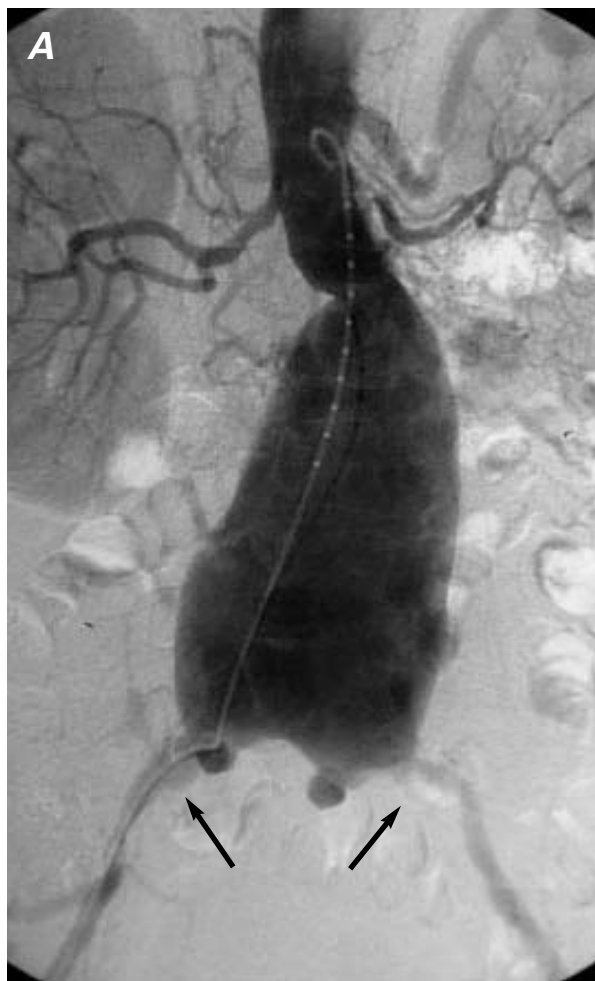
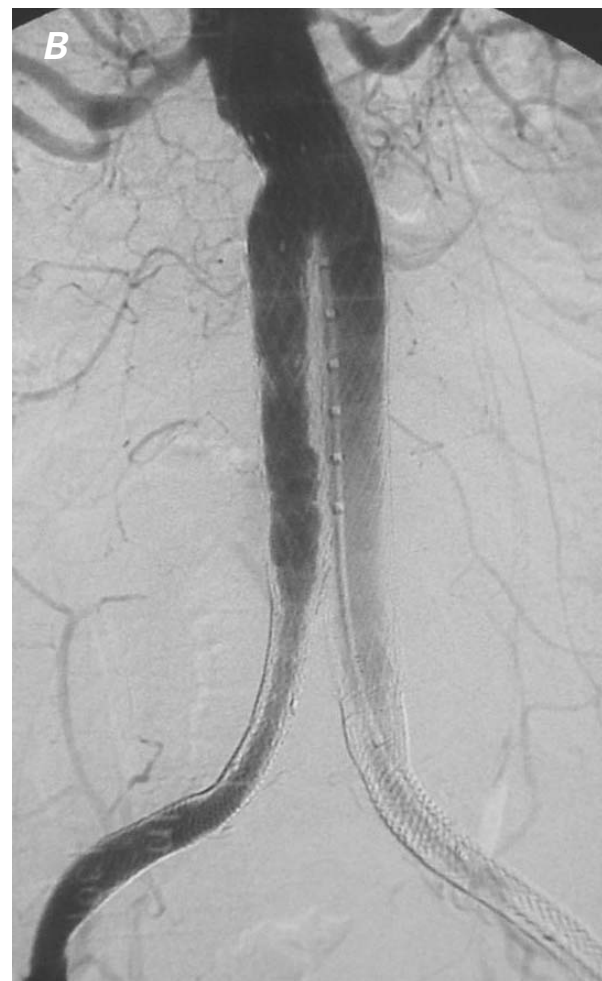
**Fig. 1** Patient 1. **A)** Abdominal angiogram before AAA exclusion, revealing very tortuous and narrow iliac arteries (arrows). **B)** Abdominal angiogram after successful deployment of the AneuRx stent graft

tery (Fig. 1B). There was no endoleak or any complication at the end of the procedure.

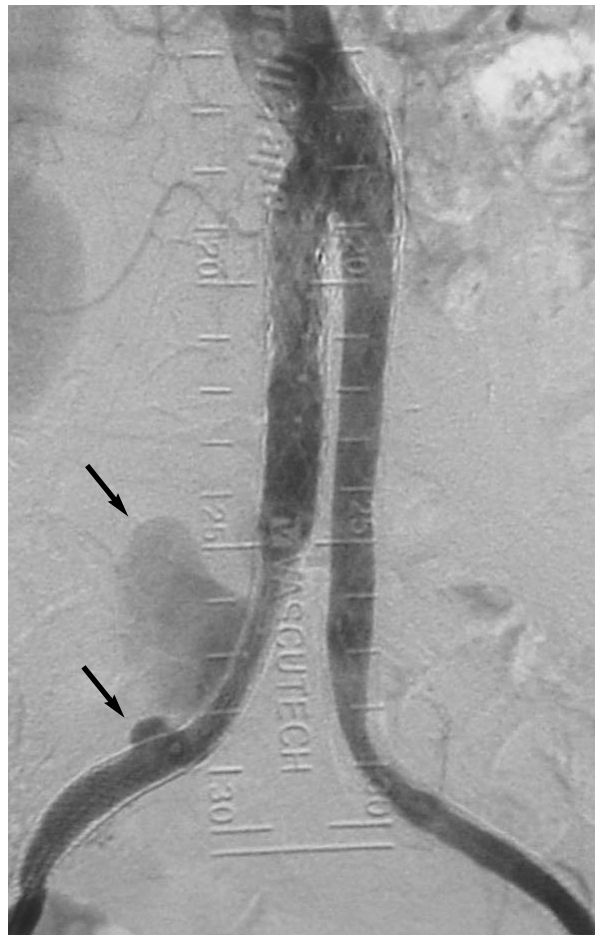
**Fig. 3** Patient 1. Abdominal angiogram shows an endoleak in the right iliac limb and a large pseudoaneurysm on the right side (arrows).

spection of the stent graft revealed suture breakage and partial ring separation from the Dacron material as the cause of a Type III endoleak. The patient recovered uneventfully from the operation.

the delivery catheter, it could not be retrieved. We also tried to pass a glide wire to perform right iliac limb angioplasty in an effort to free the delivery catheter. However, all attempts failed, and the patient underwent an open surgical repair of the AAA with removal of the entire stent graft. Surgical exploration confirmed the presence of a pseudoaneurysm that had formed at the origin of the right iliac artery. Close in-
